BRIDGE INFRASTRUCTURE IN SECONDARY ROADS OF ANTIOQUIA

KEYWORDS: bridges; roads; infrastructure; Department of Antioquia.

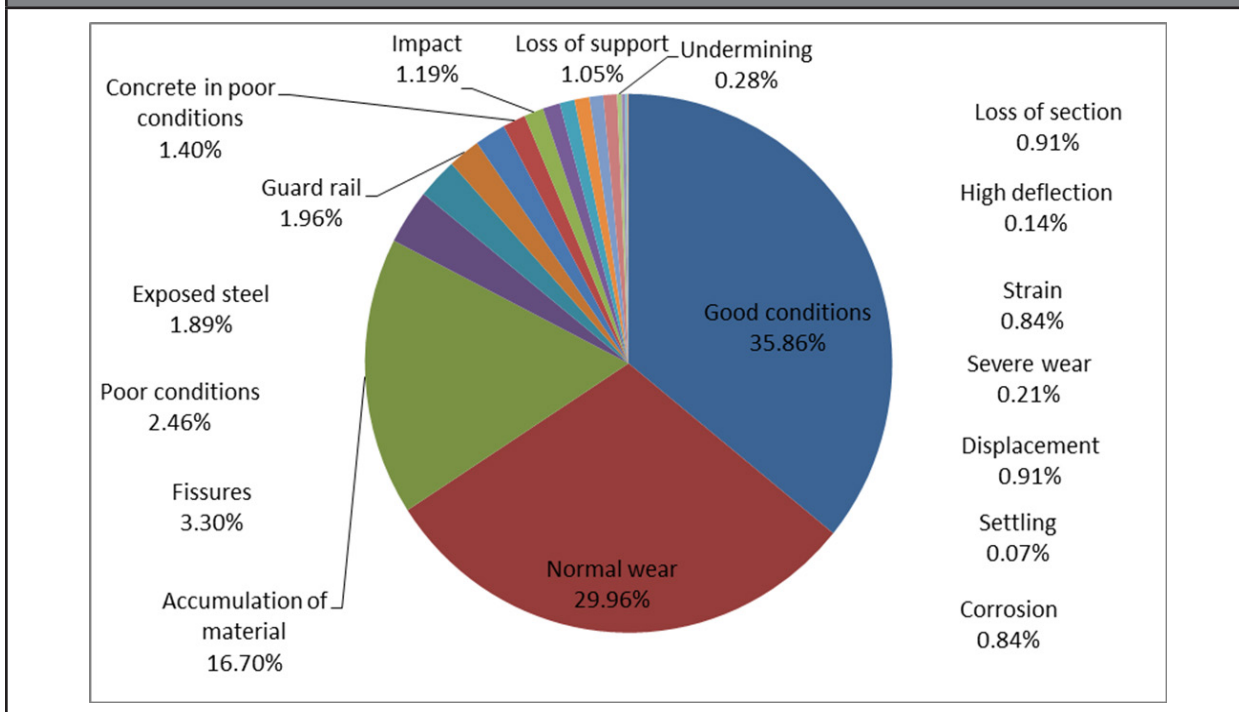
Figure 14. Superstructure conditions.

The superstructure includes all elements of a bridge that are located atop its support elements. It is generally made up of the road surface, the beams, and the upper slabs. **Figure 14** shows the report on the statistical registry of the observations made of the bridges' superstructures.

Although a large percentage of the superstructures of bridges belonging to the secondary road network of the Department of Antioquia are in good conditions, several types of functional defects were found, including normal wear due to use and the accumulation of material, which are the main factors among the defects found in the inventory.

The greatest defects in the bridges' superstructures found during the inventory were normal wear (29.96%) and the accumulation of material (16.70%). The sub-structures showed the presence of fissures in 26.42% of the cases evaluated and undermining in 18.88%.

Correct preventive maintenance of the superstructure, carried out periodically and accompanied by

clean-up teams to avoid the accumulation of material and allow for free evacuation of runoff water, is a fundamental tool for guaranteeing the proper function of the superstructures of bridges on secondary roadways in the Department of Antioquia.
